HEATEC BULLETIN

Infrared Camera Reveals Heat Losses

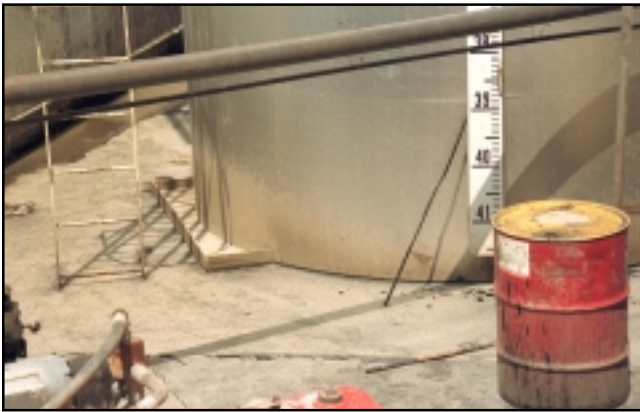
Infrared photo at right reveals high temperatures of the concrete at the base of the vertical tank shown above. The temperatures indicate that the tank is losing a significant amount of heat from its lower bulkhead. This tank is **not** made by Heatec.

It appears that the bottom of the tank in the upper photos is not insulated. This would account for the high temperatures of the concrete near the tank. The concrete directly beneath

the tank is probably hot enough to boil water. In any case, a lot of heat is being wasted.

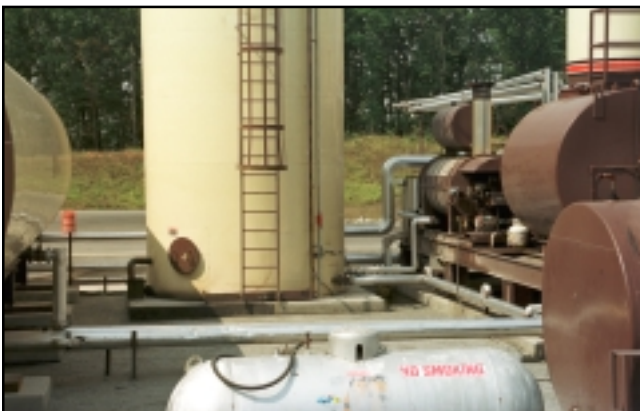
The lower bulkhead of the vertical tank shown above is insulated to minimize heat loss. Infrared photo at right shows relatively low temperatures at base of tank. This tank is made by Heatec.

The lower photos show a Heatec tank. The infrared image reveals much lower temperatures at its base. We insulate the bottom to reduce heat loss and to save you considerable money over the life of the tank. Others overlook this important detail, which is easily detected by infrared.
